BARRON RIVER BRIDGE INVESTIGATION AND DEVELOPMENT OF A REPAIR STRATEGY

Alan Carse (Structures Division) and David Hamilton (Peninsula District)
August 2005

Keywords: alkali-silica reaction, corrosion, chlorides, durability, concrete repair

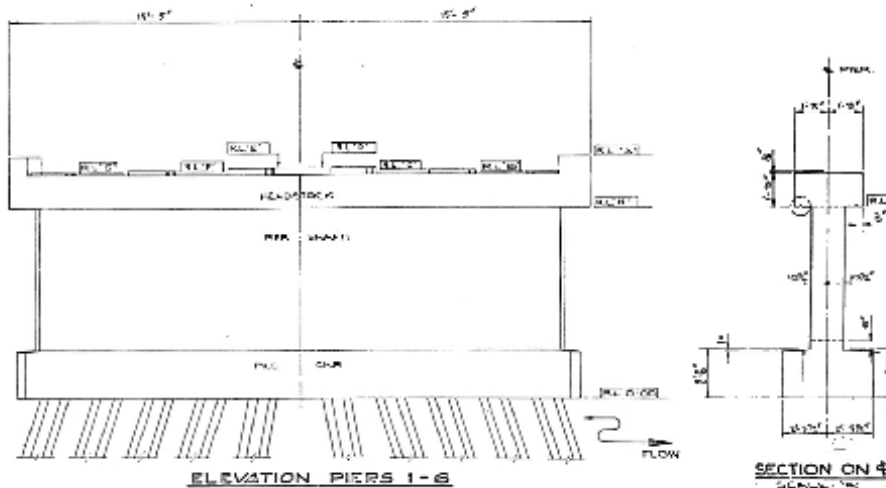
Figure II Elevation and cross section of Piers

As shown in Figure II each pier is supported on 10/450 mm octagonal prestressed concrete piles. The condition of 15 piles out of a total of 60 piles was ascertained by an underwater diving inspection. Table III contains a summary of the field condition of the piles as reported by the divers. Crack widths were reported as 10mm wide etc.

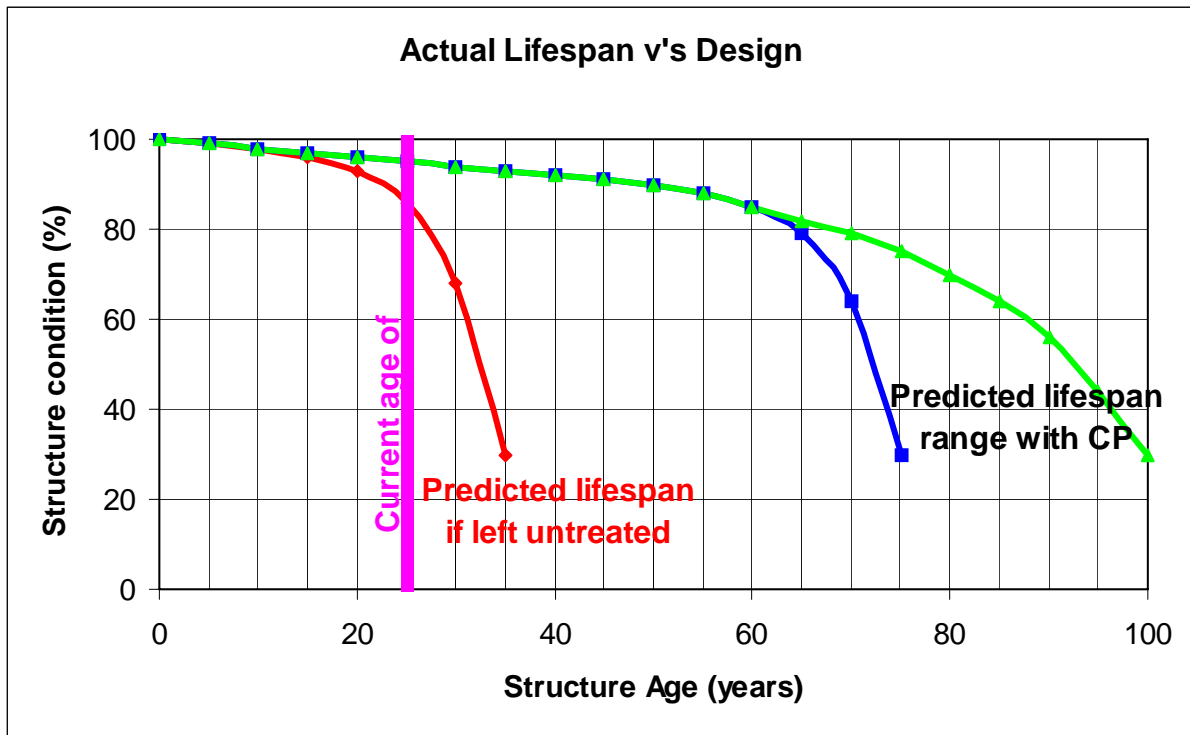
Figure VII Asset management strategy for southbound Barron River bridge piers

As a result of the significant penetration of chloride ions into the piers of the southbound bridge it was recommended that cathodic protection (cp) be installed to all the piers as soon as possible. Figure VII describes the asset management strategy being employed in relation to the cp installation and the expected additional life as a result of this intervention work. Figure VII shows an idealised diagram of structure condition versus age. While this is a rather simplistic representation of this structure's lifespan it does illustrate that without intervention

this structure is only likely to reach around $\frac{1}{3}$ of the design life originally intended. While this diagram only relates to the condition of the substructure (for example it does not consider the effect of ASR issues with the superstructure) it does however illustrate the significant effect on life expectancy, which a CP system is anticipated to have.
